Technical Note

TN_159

FT90x Errata

Version 1.1

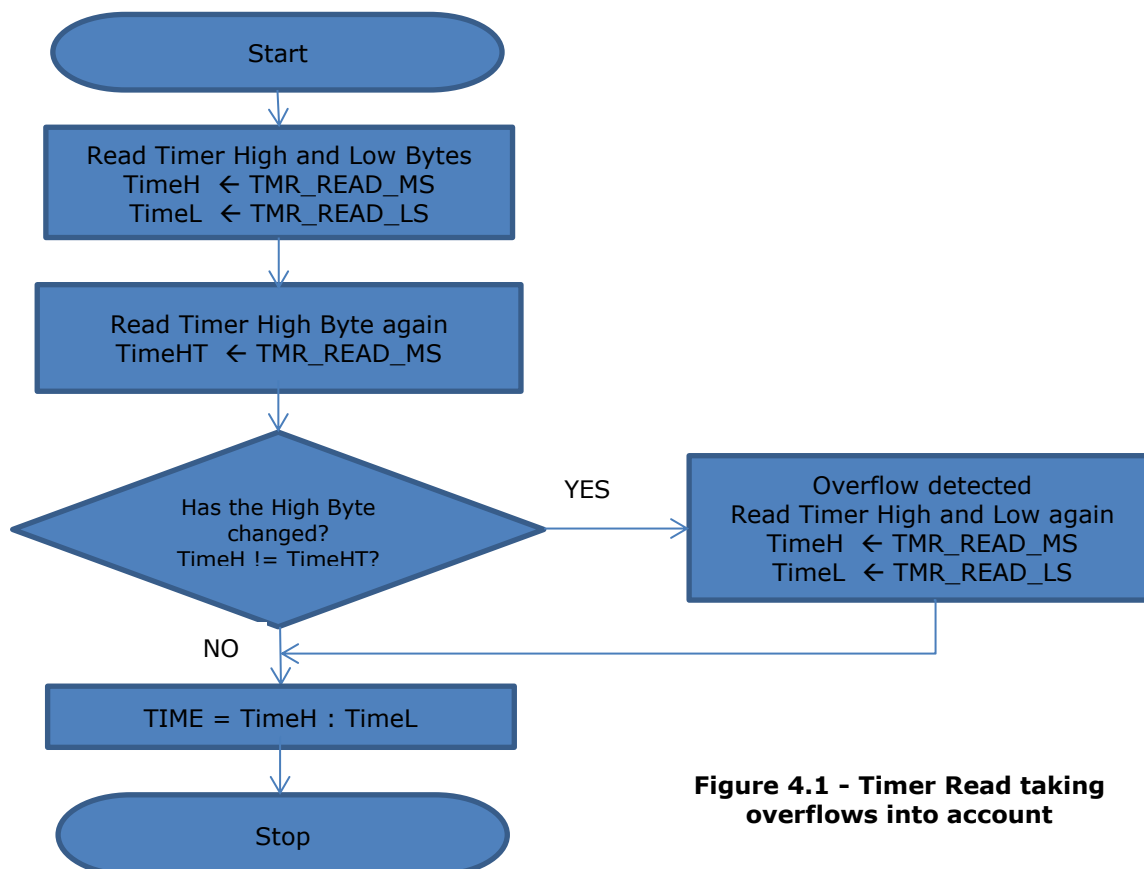
Figure 4.1 - Timer Read taking overflows into account

The FT90X series has 16-bit timers that are accessed via two 8-bit registers. Since they are not latched, the user must be careful to handle overflows while determining the final 16 bit value.

If either of the 8-bit registers overflows during the read, the resulting concatenated 16-bit value will be incorrect as illustrated in Table 6 **Error! Not a valid bookmark self-reference..**

The workaround for this is to read the high byte twice to check if there was an overflow while the low byte was being read as shown in **Error! Reference source not found..**

Note that the user must also take care that the above read sequence is not interrupted, as that could potentially lead to inconsistent values.

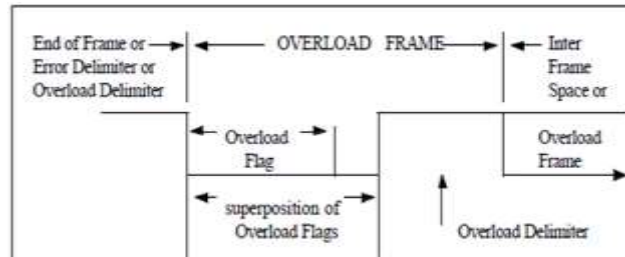
Figure 4.2 - CAN OVERLOAD Frame

The start of an OVERLOAD FRAME due to condition 1 is only allowed to be started at the first bit time of an expected INTERMISSION.

The CAN controller violates the behavior described in the specification. Instead of sending the OVERLOAD FRAME immediately after the End of Frame, the CAN controller adds one extra 'recessive' bit (1'b1) between the End of Frame and the OVERLOAD FRAME.

Currently, there is no workaround for this issue.

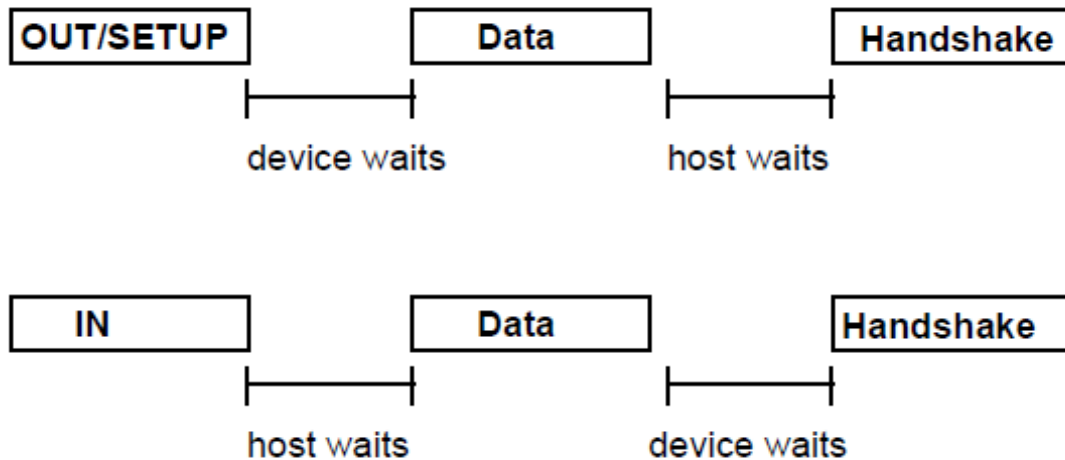
Figure 4.4 - Bus Turn-around Timer Usage (copied from USB 2.0 Specification)

The USB Device Controller doesn't check for bus turn-around timeout between OUT/SETUP token and data phases. It will accept the data and respond with ACK.

Currently, there is no workaround for this issue.
